RE: Review of the Sonoita Creek Mitigation Project Proposal for the Proposed Rosemont Copper Mine

**Review of the Sonoita Creek Mitigation Project Proposal for
the Proposed Rosemont Copper Mine**

G. Mathias Kondolf, PhD
2241 Ward Street, Berkeley CA
mattkondolf@gmail.com

29 December 2017

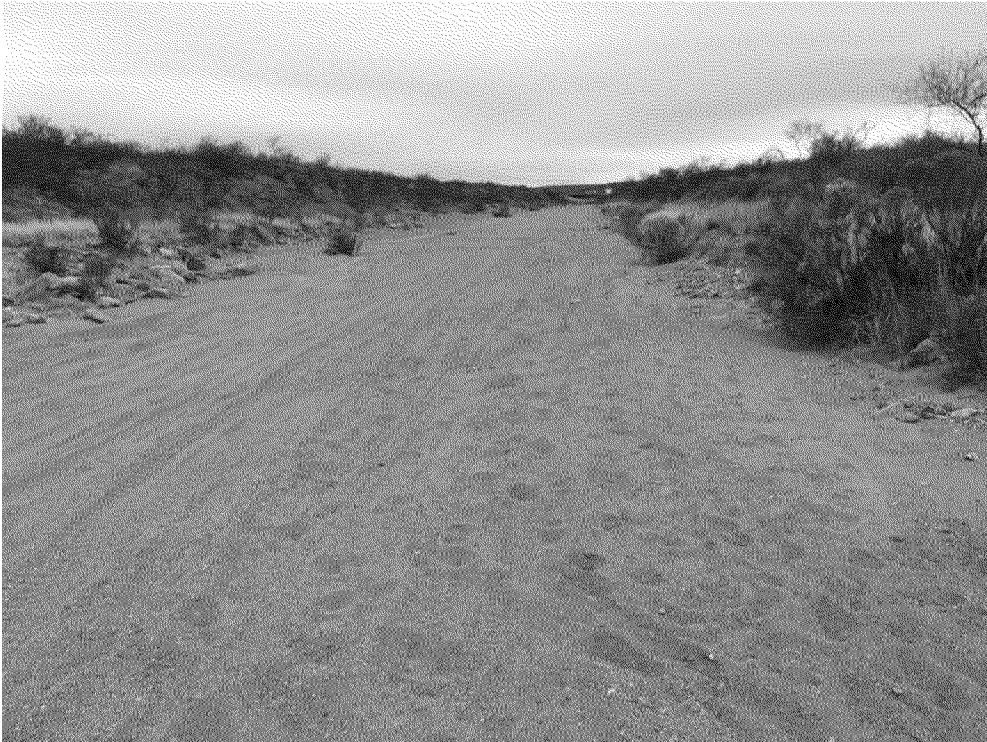
Figure 2. Photo looking upstream along the straight channel of Walnut Gulch towards Flume 6, visible in the distance. (photo by author, December 2017)

In a section entitled “Comparison of Sonoita Creek to Walnut Gulch Experimental Watershed, WET (2017:13) argues that Walnut Gulch provides “hydrologic and geomorphic analogues to Sonoita Creek” and cites Exhibit 1, which shows strip maps of reaches of Walnut Gulch and Sonoita Creek. The text refers repeatedly to the reach of Walnut Gulch near Flume 6 (one of the measurement stations established for monitoring flow on the experimental watershed), asserting that “Walnut Gulch has numerous reaches exhibiting broad, shallow channel forms with significant braiding near to, and downstream of, Flume 6.” (WET 2017:13) The implication is certainly that what we see in Exhibit 1 is illustrating the points made in the text, and indeed Exhibit 1 is annotated with circles to highlight “braided multi-channel areas”, supporting the assertions of channel braiding in the text. The problem with this is that the reach shown in the Walnut Gulch map in Exhibit 1 is *not* the reach near Flume 6, but a reach beginning about 3 miles downstream, with a larger drainage area. The Exhibit 1 map is annotated with a label for Flume 7 (on a tributary drainage) at the extreme right, and for Flume 1 near the center of the map. Contrary to the statements in the text, inspection of aerial imagery of the reach of Walnut Gulch below Flume 6 (Figure 1b) shows that it is nearly all single-thread and very straight (Figures 1b and 2). Nonetheless, the reach of Walnut Gulch near Flume 6 was used by WET (2017) as a reference for channel dimensions for its channel design on Sonoita Creek. The implication that the Walnut Gulch reference reach provides support for a multi-thread or highly sinuous channel design on Sonoita Creek is misleading at best.

WET (2017:13) also lists characteristics of Walnut Gulch at Flume 6 that it says are similar to Sonoita Creek (drainage area, channel gradient, and coarse sandy substrate). Only on the next page does it mention average rainfall values, which it reports as 12-14 inches/year for Walnut Gulch, and 18-20 inches/year for Sonoita Creek. These very large differences in rainfall went unmentioned in the argument for using Walnut Gulch as a reference reach, and undermine the argument that the sites are comparable.
